PRELIMINARY OBSERVATIONS OF THE DARFIELD (CANTERBURY) EARTHQUAKE: UNIVERSITY OF CANTERBURY BUILDINGS

Bruce L. Deam¹ Mary Comerio² and Jeff Clendon³

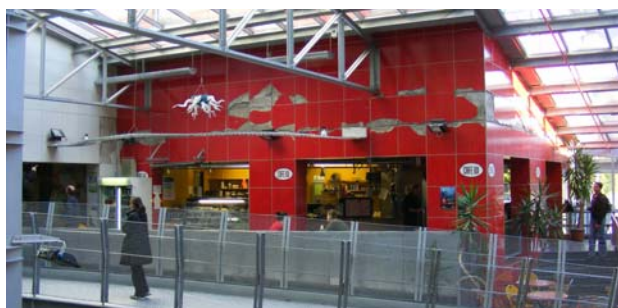
The best example of inadequate interior finishing was in the relatively new six-storey Commerce Building (built 1998). The reinforced concrete moment-frame building has a V-shaped floor plan and lecture theatres in the basement and ground storeys. One leg of the V has a cafeteria at its base, which is slightly above the entry-lobby ground level (Figure 3). There is a two-storey structure closing the V that is laterally braced with structural walls. There were well-detailed sliding joints to accommodate differential movement between the tower frame and both the cafeteria and the two-storey structure, however the finishing tiles were not able to accommodate either the movement or the minor chipping of the edges of the concrete components as they slid over each other (Figure 3).

Figure 3. Finishing tile damage around sliding seismic joint in the Commerce building

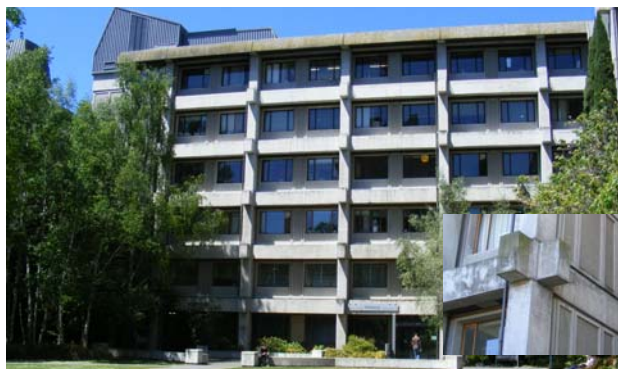
Figure 5. The History building, with an inset showing its decorative beam stubs that provide reinforcing anchorage

The History building (Figure 5) provided a second illustration of the need for well detailed connections between frames and walls within a building. This reinforced concrete moment-frame building was originally three storeys high but had another three storeys and an elevator tower added in the 1980s.

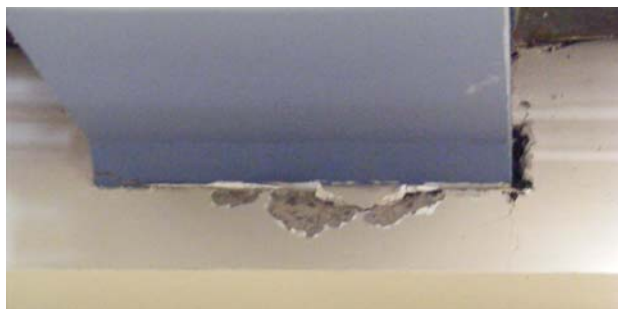
Figure 7. Movement of the stairway on its supporting ledge at Level 3 in the History building

The stairway in the 6-storey History building was partially damaged by the interstorey drift movements. Each storey has U-shaped stairs seated on ledges at the top and bottom, and mid-flight landings that are bolted to the columns either side of the stairwell. The stairs clearly slid across their ledges during the earthquake (Figure 7), stretching the long bolts holding the stair flights to the ledge beams, tearing the vinyl floor coverings and chipping concrete from the leading edges of the ledges. Like the Commerce building, this damage was not significant structurally, but it compromised fire egress and therefore needed to be repaired before the building could be fully reoccupied.

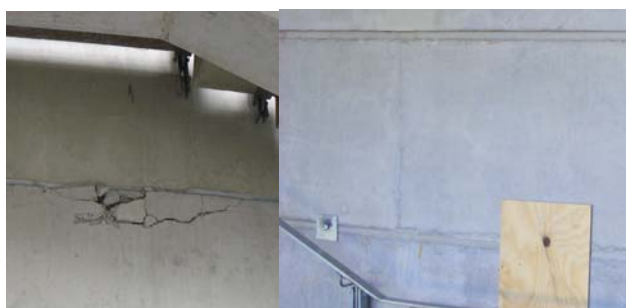
concrete panels attached to the structural frame. Anchors cast into the panels allowed these to be bolted to supports cast into the supporting frame. Slots in upper connection were detailed to accommodate in-plane interstorey drift and the panels have gaps along the top and at each end. Severe concrete damage around the top anchorage points of most of the precast panels (Figure 4) suggests that the bolts were unable to slide through the slots as intended.

While the damage was minor, and temporary connections were easily inserted to retain the panels during aftershocks, the failure of this very small design detail created significant consequences for both fire egress through the stairwell and operation of the elevators.

Figure 4. Elevator panel damage around restraint bolts and (later) temporary restraint in the Commerce building

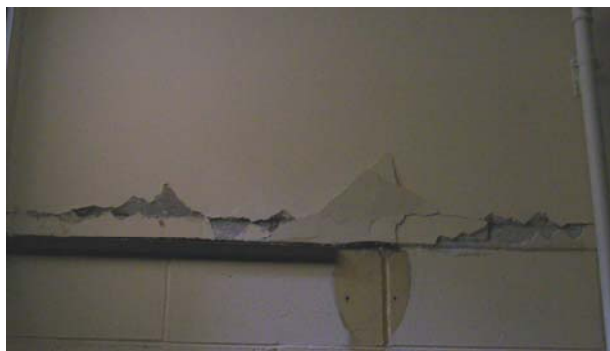
Figure 6. Finishing damage at top of masonry infill panel within the Te Pourewa building

The 6-storey reinforced concrete moment-frame Te Pourewa building (on the College of Education site to the west of the main campus) had some minor damage due to movement of the frame relative to a concrete block masonry infill panel (Figure 6). There was clear evidence of sliding along the top of the infill panel, but no other visible damage to the panel. Some of the architectural ‘spandrel panels’ between two structural walls on the north face of the Te Pourewa building were slightly damaged as well.

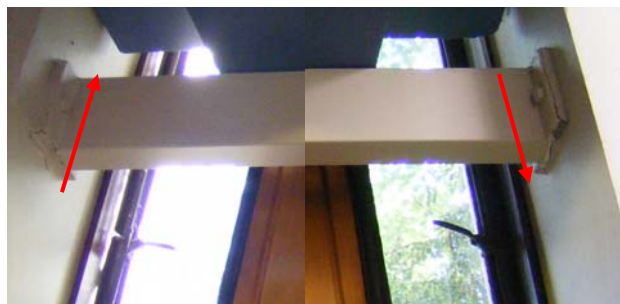
Figure 8. Vertical movements of the landing supports between Levels 2 and 3 in the History building

The gaps between the stair flights and their landings varied with height in the History building, with about 10 mm gap at level 2, the largest gap of about 15 mm gap at level 3 and progressively smaller gaps at the higher levels. This is consistent with the interstorey drift profile for a frame building. However, the building was not noticeably offset after the earthquake, and the permanent gaps appear to have been accommodated by small vertical offsets in the bolted connections at the sides of the mid-flight landings (Figure 8).

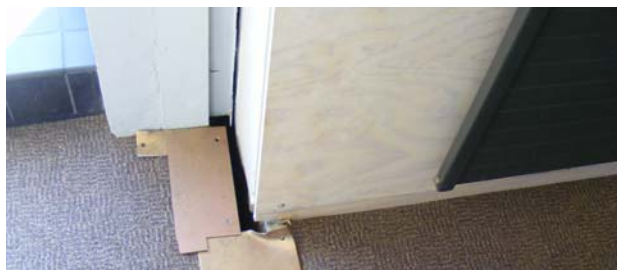
Figure 9. Movement at level 8 between the lift block (left) and southern portion of the Rutherford building

The 8-storey Rutherford Building (Chemistry and Physics, circa 1970) had evidence of significant movements within the seismic joints at both floor and ceiling of the 8th floor (Figure 9) and progressively smaller movements at lower levels. One roof frame beam was cracked about 1 m from the column (Figure 10), suggesting a significant gravity load and a unidirectional structural hinge.

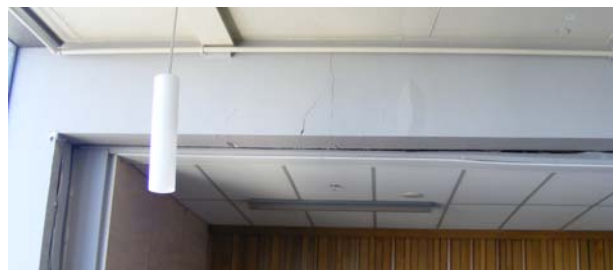
Figure 10. One-way hinging of the roof beam in the Rutherford building (immediately above Figure 9)

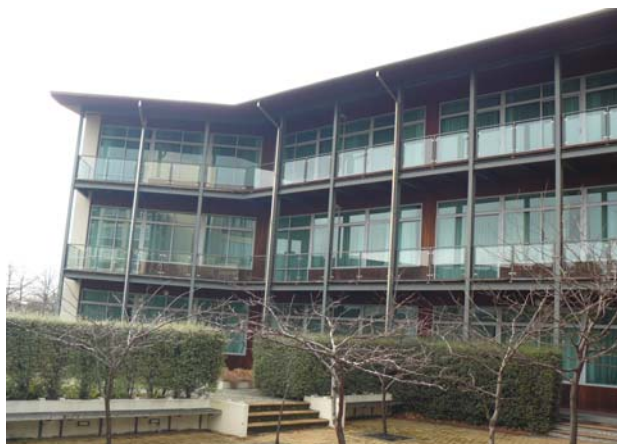
There were also cracks observed in lateral load-resisting systems, such as those in the 3-storey portion of the Wheki building (College of Education). The plan view of this building is like one quadrant cut from an octagonal building (Figures 11 & 12). It has a steel frame supporting the floors and 3-storey high tilt-up concrete panels at the two ends and around the outer three faces. The three inner faces are glazed and provide minimal lateral load resistance. There was no evidence of cracking in the two structural walls at the ends of the building (these two walls were perpendicular to each other). There were diagonal cracks at some of the corners of the window cut-outs in the bottom storey of the outer faces of

Figure 11. The Whiki building, showing a half-octant on the left and the central octant to the right. (Photo: Tony Abu)

the building. Interestingly, the cracks were almost all on the top-left and bottom-right corners at one end (the face to the right of Figure 10) but at the opposite corners at the other end of the building (the outer face behind the centre of Figure 11), suggesting an impulsive ground motion rather than oscillation.

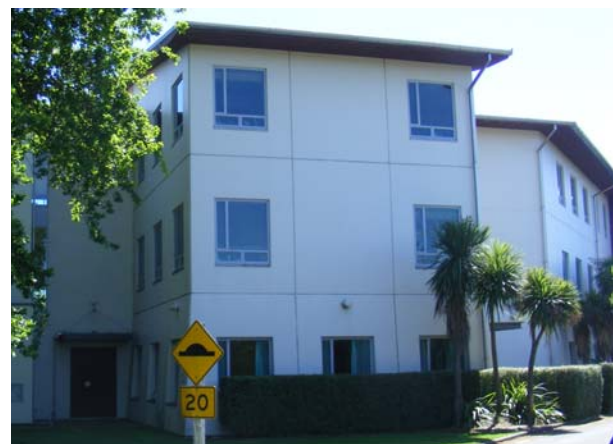
Figure 12. Behind the Whiki building. The elevator tower had cracks adjacent to the access door (lower left).

Diagonal cracks (< 1 mm) were also observed in a structural wall adjacent to the elevator within the 3-storey atrium between the 3 and 4 storey wings of the Wheki building (Figure 12). The stairway within the atrium dropped several millimetres vertically at the intermediate landings, causing the finishing tiles to spall from the central supporting wall. The seismic joint cover plates between the atrium and structural wall at the end of the adjacent 4-storey wing lifted and prevented some of the access (and fire egress) doors opening.

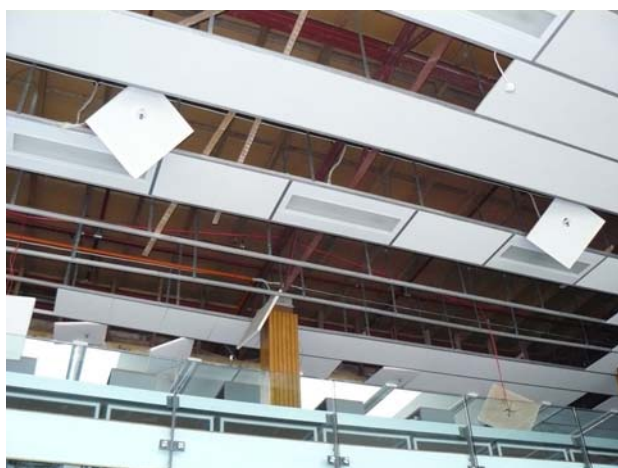
Figure 13. The remaining roof-level suspended ceiling within the Engineering and Physical Sciences Library (Photo: Tony Abu)

The 3-storey Engineering and Physical Sciences Library (circa 1970) shed a significant portion of the ceiling tiles at the roof level (Figure 13). The ceiling system only had support rails in one direction. Unbroken ceiling tiles were used to replace tiles fallen from the sloping ceilings of the larger single-storey engineering lecture theatres (E1, E8 and E9), allowing them to be reused for teaching two weeks after the earthquake. The ground floor of the Library reopened 10 days after the earthquake, but the upper levels were closed for student use for another two weeks.

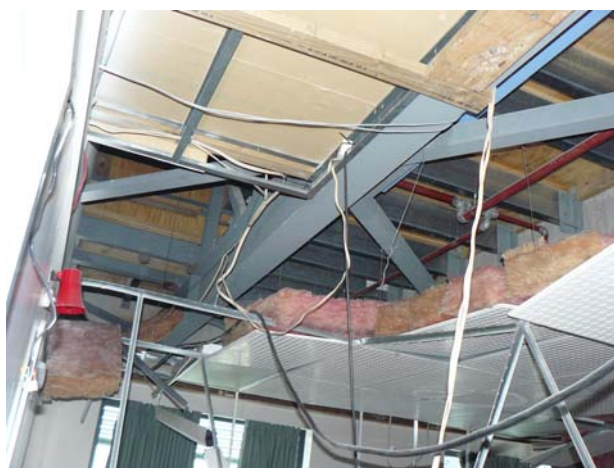
One meeting room ceiling at the top of the 5-storey Civil and Mechanical Engineering building (built 1997) shed many ceiling tiles (Figure 14). This was possibly in part due to the large area of the ceiling as no tiles were shed from smaller office ceilings at the same level or from an identical meeting room one floor below, which had been partitioned into offices a year before the earthquake.

Figure 14. Tiles shed from a more modern ceiling with support rails in both directions (Photo: Tony Abu)

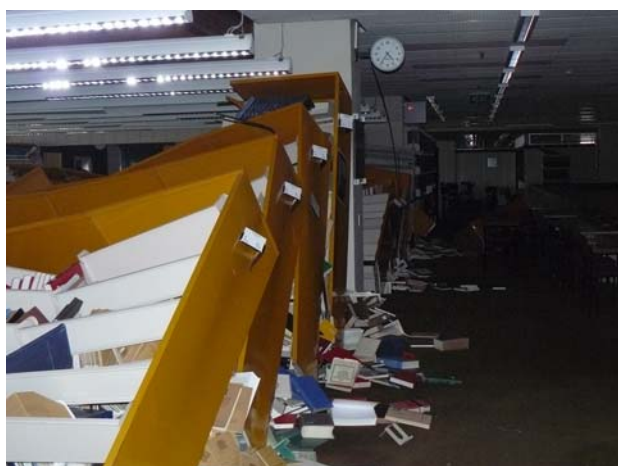
Figure 15. Collapsed book stacks at Level 3 of the James Hight Library (Photo: Tony Abu)

The James Hight library is the tallest building on the campus and images of its collapsed book stacks (Figure 15) were used extensively by the media to characterise the damage at the University. The library comprises a central 12-storey tower that is surrounded on three sides by 3-storey podium buildings. This configuration partly contributed to the unusual pattern of damage observed in the building. In this case, the most extensive damage was on the second and third floors, with many broken windows and collapsed book stacks. The windows, like many on the campus, have steel frames that are rigidly attached to the reinforced concrete frame and the glass in turn is semi-rigidly sealed into its frame with glazing putty. The final replacement glass was installed six weeks after the earthquake.

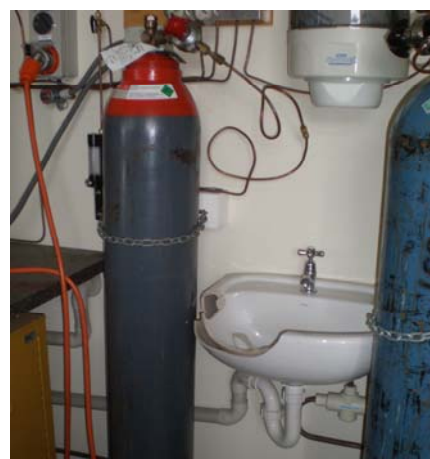
Figure 16. Gas cylinder restraints and the hand basin damage when chain detached during the earthquake

Most tall gas tanks were restrained with chains but in some cases, the shaking loosened the chain from the I-hook and the tank fell (Figure 16). In the future, these will be secured with a closed hook.
